**POTENTIAL JURISDICTIONAL
WATERS EVALUATION**

**WOODLANDS GOLF CLUB
SEAFORD, DELAWARE**

May 2010

Project No. 7864.EB

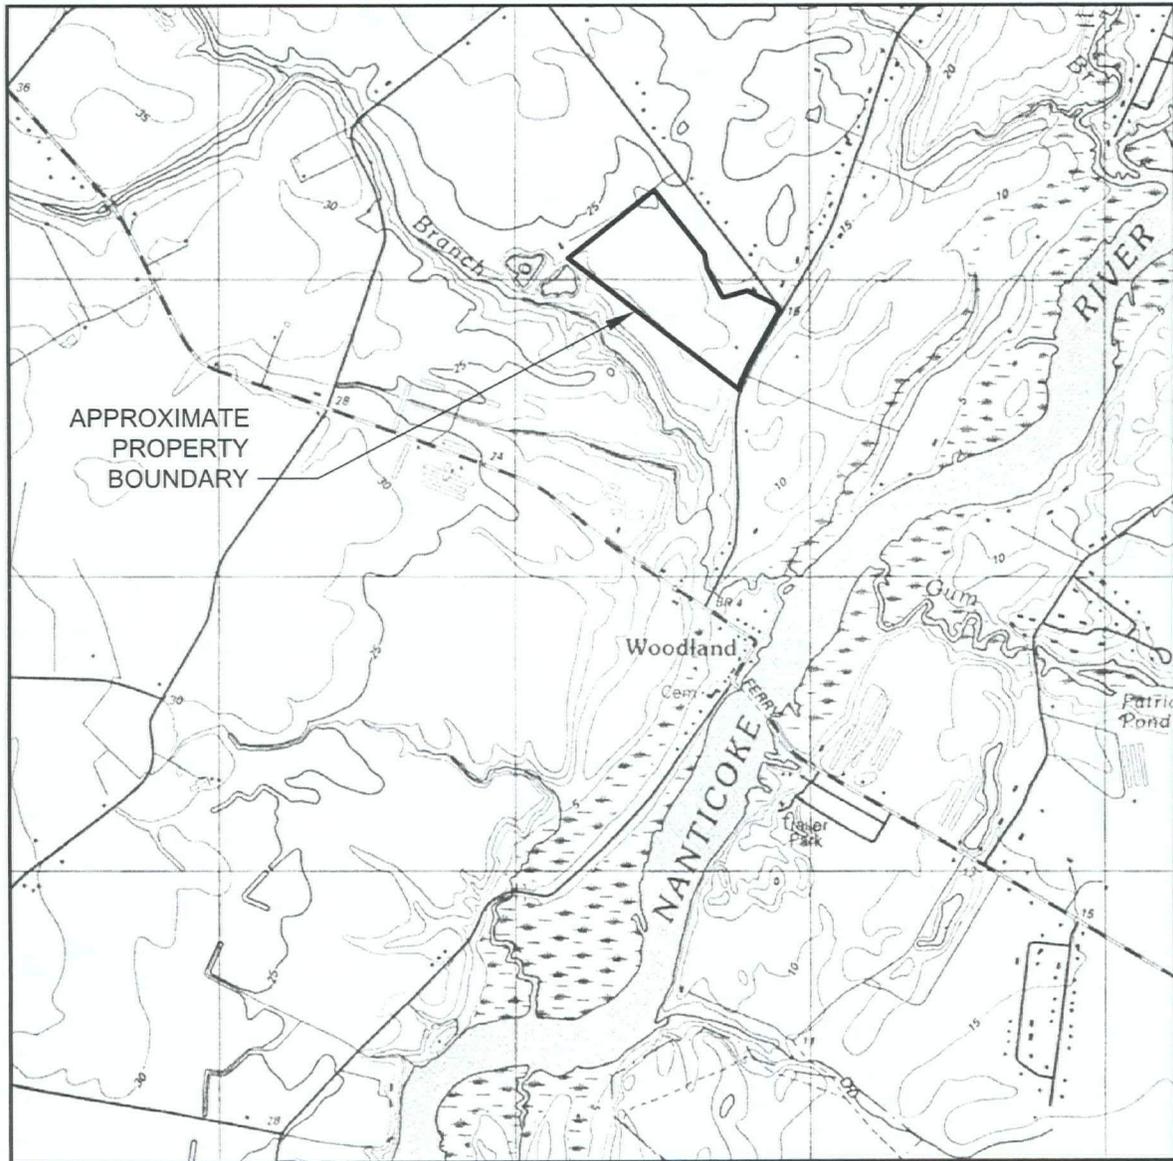
FIGURE 1
U.S.G.S. TOPOGRAPHIC MAP
LOCATION SKETCH

Based on a review of the applicable USGS topographic map, the elevation of the Property ranges from approximately 15 to 25 feet above mean sea level. The Property slopes south-southeast towards Turtle Branch based on the topographic map and the site reconnaissance (see Figure 1).

According to the USGS topographic map, there are no water features present on the Property. Turtle Branch is approximately 200 feet from the Property's southwestern border and flows southeast to the Nanticoke River.

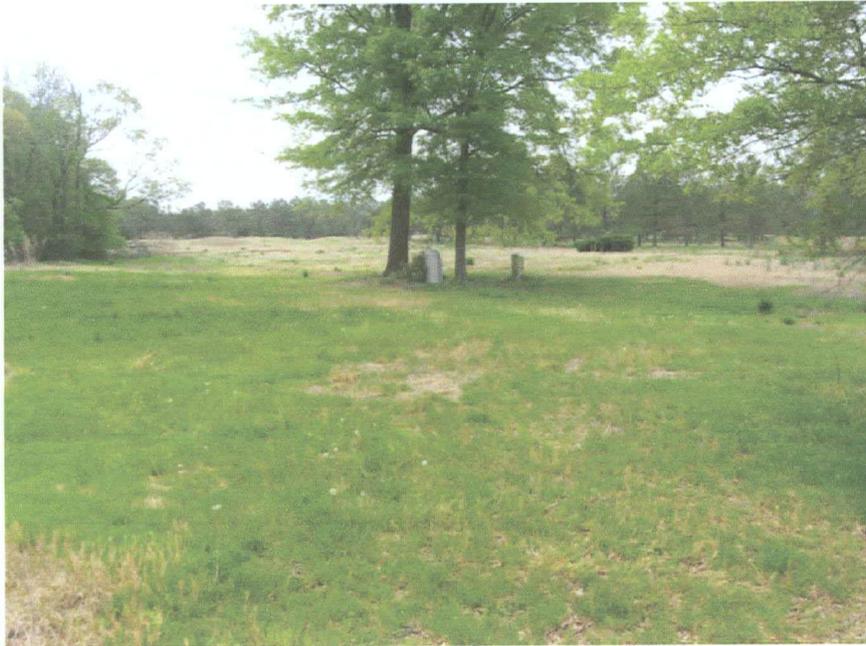
The former golf park is vegetated with grasses and sporadic pine trees throughout (Photograph 1). Three (3) man-made ponds are present on the Property (Photographs 2 and 3). These ponds apparently were constructed during the development of the golf course in upland areas. One (1) agricultural ditch borders the proposed eastern boundary of the Property. The ditch was not flowing but contained standing water (Photograph 4). This ditch does not apparently connect via culvert or other means to the ponds. Vegetation in the ditch consisted of trees (e.g., red maple and red cypress). Soil borings were not conducted as apparent wetland areas were not observed.

Photograph 1 –Woodlands Golf Park, vegetated with grasses and sporadic pine trees.

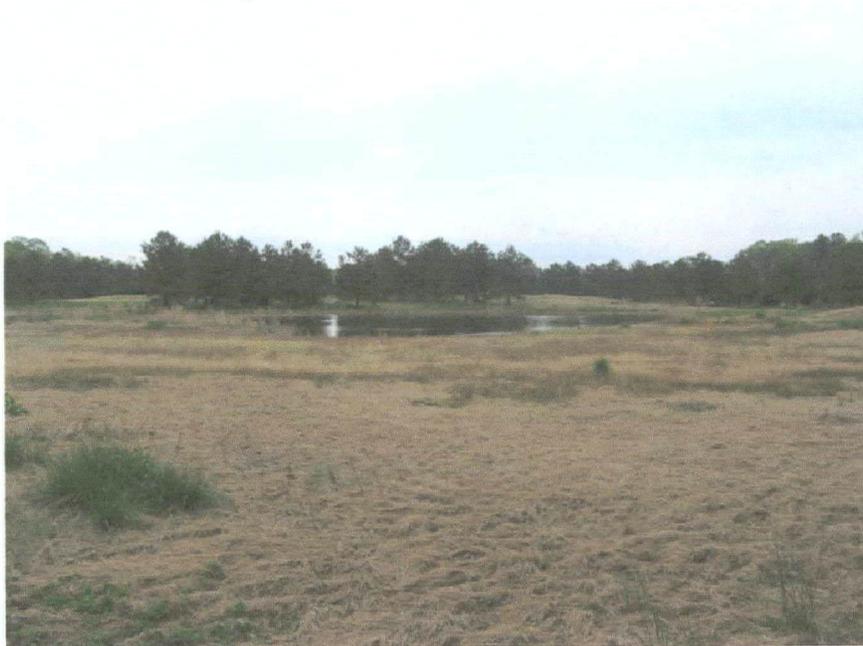
Four (4) water features were observed during the site reconnaissance; three (3) ponds and the agricultural ditch. Based on historical aerial photography review, the three (3) ponds present on the Property appear to be man-made features constructed in uplands when the golf park was developed. Based on aerial photography review, the ditch that borders the east Property boundary was constructed for agricultural purposes. The ditch did not have flowing water or an apparent ordinary high water mark. These ponds and the ditch are not depicted on the USGS, Soil Survey, NWI, SWMP, or FEMA maps.

Photograph 2 –Eastern, man-made pond constructed in uplands for the golf park.

Man-made ponds constructed in uplands, which have no connectivity or exchange with other jurisdictional waters, are not regulated water bodies. It is Duffield Associates' opinion that the three (3) ponds on the Property are man-made features, constructed in uplands and are not water features that would fall under the jurisdiction of state or federal regulatory agencies.

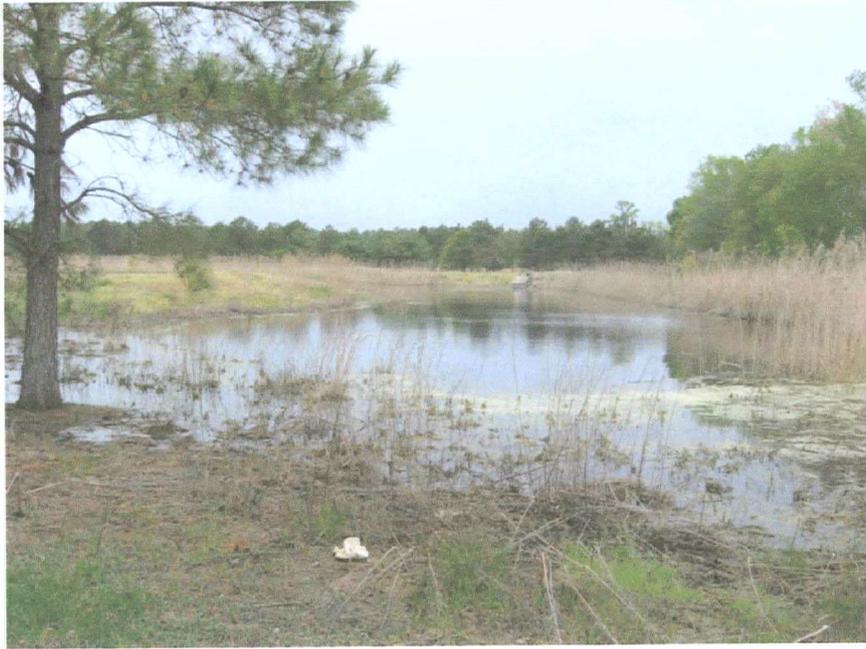
Photograph 3 –Western, man-made pond, constructed in uplands.

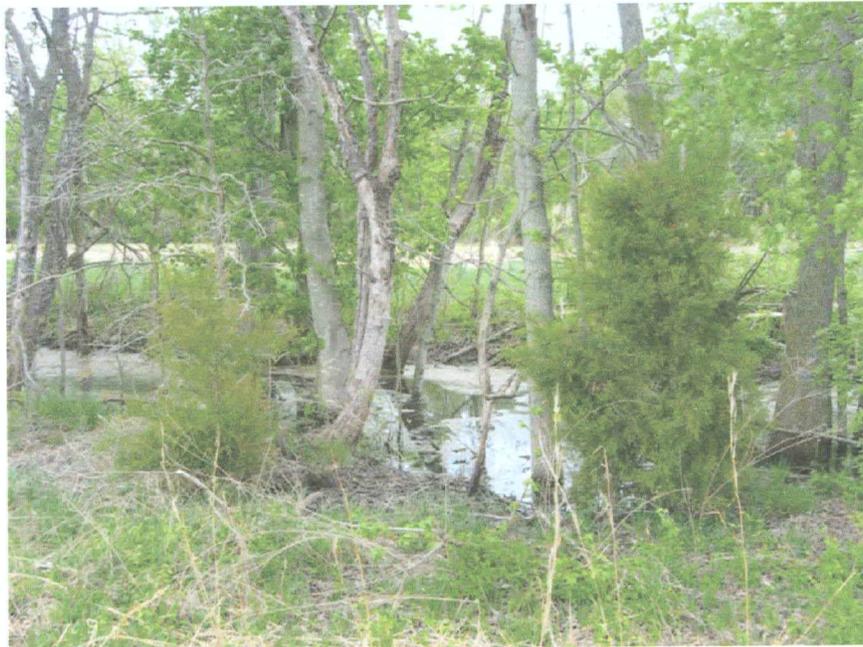
Four (4) water features were observed during the site reconnaissance. The three (3) ponds were constructed during the golf park development as ornamental features. Based on aerial photograph review, these features were constructed in upland areas. These ponds do not appear to be connected to the agricultural ditch. The agricultural ditch, the fourth water feature observed was apparently constructed and maintained as an agricultural ditch during the farming practices prior to the development of the golf park.

Photograph 4 –Agricultural ditch at proposed east Property boundary.

The agricultural ditch, however, is a water feature that could potentially be a regulated water body. If work is proposed within the agricultural ditch, it is the opinion of Duffield Associates that a waters of the U.S. delineation with flagging and survey be conducted, and jurisdictional determination be obtained from the State of Delaware, Department of Natural Resources and Environmental Control, Wetlands and Subaqueous Lands Section and U.S. Army Corps of Engineers regulatory agencies.
